### PCB Hot Spot TCRA Progress Excavations Complete

Hunters Point Naval Shipyard BCT Meeting – January 26, 2012\_6

### **Experimental Ship Shielding Range**

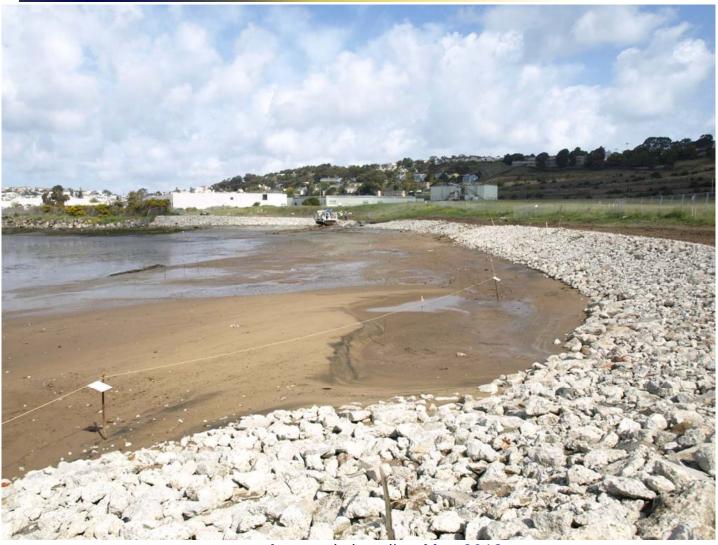
### PCB Hot Spot - Tiers 1 and 3

- 100% of grids excavated, sampled, and backfilled
- 21,771 cy excavated from Tier 1
- 10,607 cy excavated from Tier 2
- Placement of temporary shoreline revetment complete

Armored shoreline May 2012

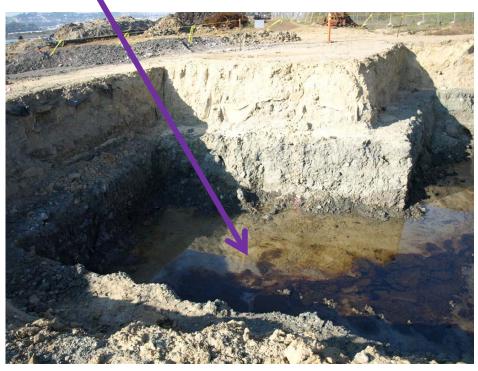
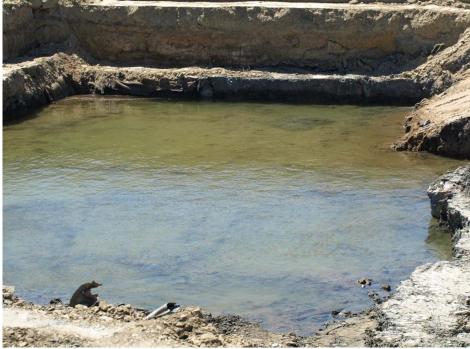
- 100% of grids excavated and confirmation sampled
- Grid 231 sidewall has TPH (9,000 mg/kg) and Pb (111,000 mg/kg) exceedances remaining
- Grid 224 over-excavated to 12 feet bgs for TPH
  - Additional 850 cy removed in May
  - Post-excavation samples below PALs
- Grid 226 sidewall had TPH (4,230 and 4,010 mg/kg) exceedances
  - 4,010 mg/kg sidewall overexcavated and TPH increased (12,030, 13,030, and 13,360 mg/kg)
- Grid 227 sidewall had PCB and TPH (120/80, 260/14,200 and 50/4,700 mg/kg) exceedances
  - Additional 950 cy removed in June for both Grid 226 and 227
  - Post-excavation samples below PALs in Grid 227
- 6,400 cy excavated

Previous 8' SW sample TPH = 15,907 mg/kg

TPH PAL = 3,500 mg/kg

Southwestern section of Grid 224 had visible TPH looking east. Conducted additional over-excavations in May.

Confirmation samples show that grid meet PALs.

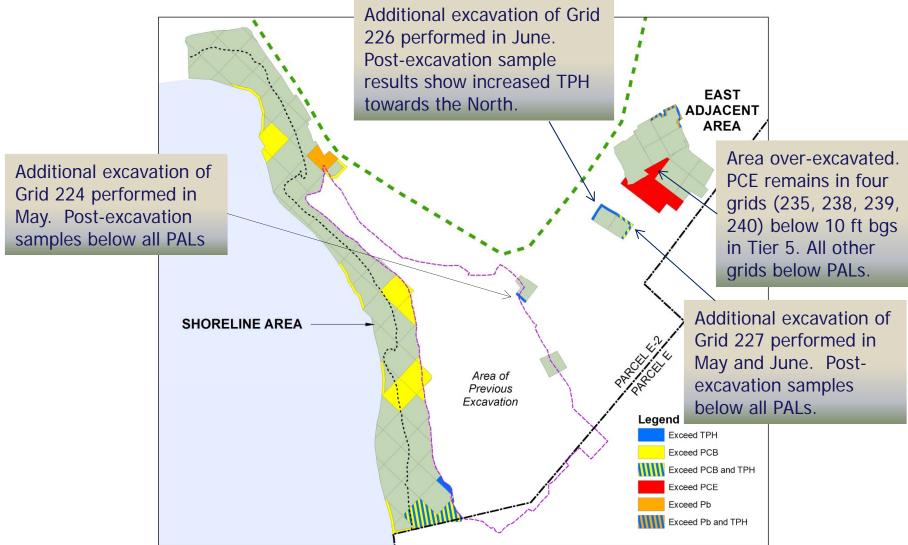
#### PCB Hot Spot - Tier 3 and 5 Summary

- 100% of grids (8) excavated and confirmation sampled
- 3,538 cy excavated
- VOC confirmation sampling complete, all grids below PALs at 10 ft bgs. Above PALs in Grids 235, 238, 239, and 240 (PCE) (below 10 ft bgs)

Tier	Grid	Lead (19,700)	tTPH (3,500)	tPCB (74)	1,1 Dichloroethane (2.8)	tetrachloroethene (0.48)	Trichloroethene (2.9)	vinyl chloride (0.024)
5	235-B-10	38.5	347.0502	0.1	ND	2.38	0.267	ND
5	238-B-11	1.63	9.2028J	0.002J	ND	4.61	0.0631J	ND
5	239-B-11	2.5	0.0314J	0.00436	ND	5.17	0.0845J	ND
5	240-B-11	16.9	0.0207J	0.0417	0.00395	2.32	0.395	ND

- Tier 1
  - TPH and PCB exceedances along Parcels E and F boundaries
- Tier 2
  - TPH and PCB exceedances along Parcel F and PCB and Pb exceedances in Grid 174 along Landfill
- Tier 3
  - Grid 231 sidewall (PALs exceeded for TPH and Pb)
  - Grid 226 sidewall (PALs exceeded for TPH)
- Tier 5
  - Grids 235, 238 (PALs exceeded for PCE >10 ft bgs)

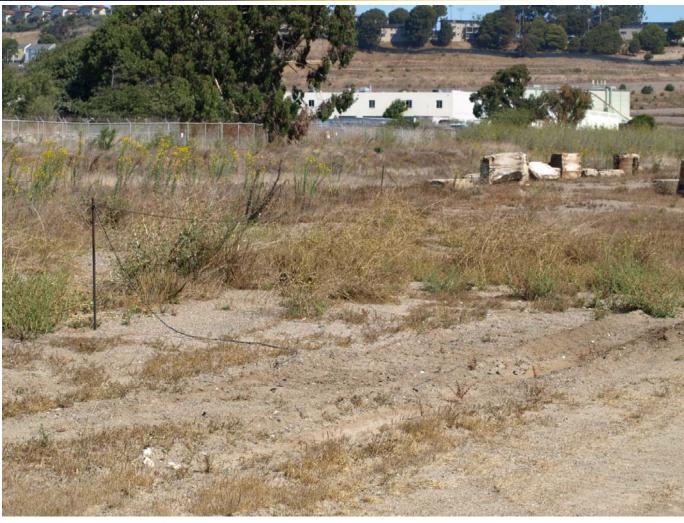
# **Experimental Ship Shielding Range Site Photograph**

- According to HRA, radioactive material was used at the Shielding Range - conducted shielding experimentation for ships
- Former Shielding Range comprises three parts:
  - A fan-shaped, post-exposure reflection/refraction field measuring 150 feet in radius (Area A) and a berm, approximately 550 feet in length
  - A 60-foot by 50-foot site designated as Area B
  - A 60-foot by 35-foot area designated as Area C
- Little is known about the specific use of the different areas that comprised the Shielding Range

Shielding Range looking northeast, berm in background

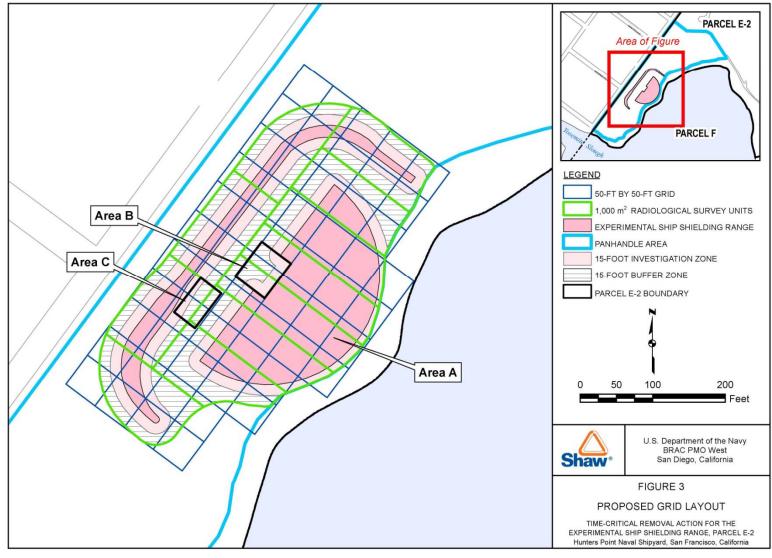
# **Experimental Ship Shielding Range Grid Layout**

- Laid out 50-foot by 50-foot radiological survey grid
- Commenced pre-work for gamma walkover surveys of Shielding Range and buffer zones
- Installed perimeter fence and stormwater pollution prevention controls
- Commenced relocation of wood debris pile and keel blocks to staging area located within the Panhandle Area

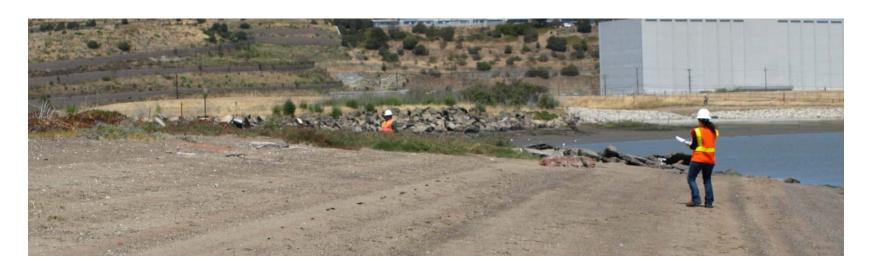
- Mobilized to site on May 29, 2012
- Performed biological survey (pedestrian avian clearance and nest survey) on May 29
- Performed geophysical survey of Shielding Range berm and fan-shaped area on June 1
- Performed topographical/land survey of area

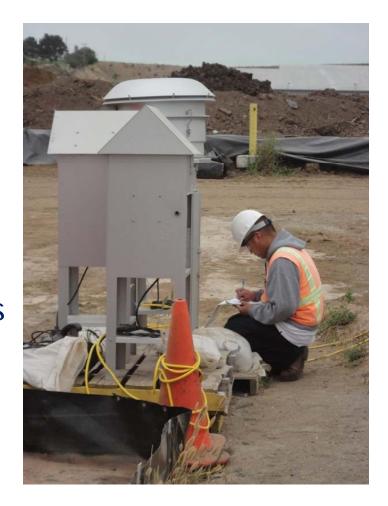
- Collected pre-excavation waste characterization samples
  - 1 sample collected / 500 cy
  - 7 samples collected total
- Commenced air monitoring in preparation for intrusive activities
